Manhole Inspection Summary

Manhole # S51CC_005MH

Insp Date: **6/27/08 11:19 AM**

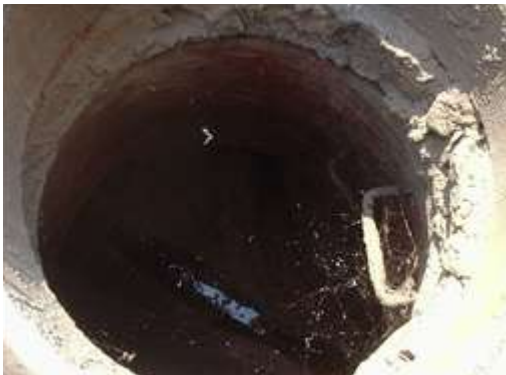
Defect 2

Count: **3** Missing: **0** ☒ **Corroded**

Corrosion

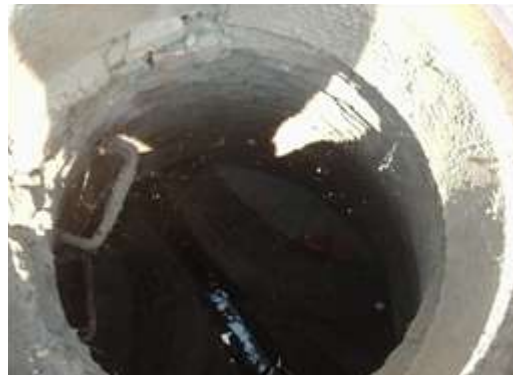
Defect 1

Condition: ☐ Sound ☐ Cracked ☐ Root Intrusion ☒ **Loose Brick** ☐ Deteriorated

Infiltration: ☐ None ☐ Joint ☐ Cracks ☒ **Mortar** ☐ Roots ☐ Wall

loose bricks

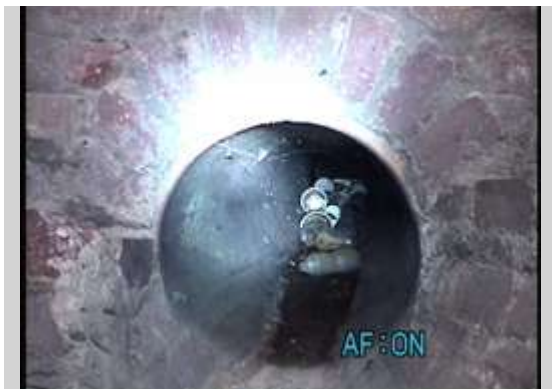
7 O'Clock Inflow

Deposits: ☐ None ☐ Mud ☐ Sludge ☒ **Debris** ☐ Grease

Silt Depth: **0** (in.) Deposits Extent: **Medium**

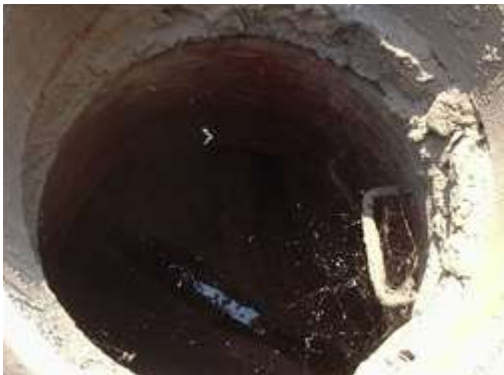
Defect 2

Count: **3** Missing: **0** ☒ **Corroded**

Corrosion

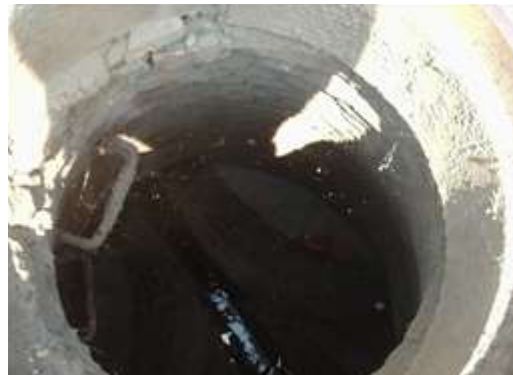
Defect 1

Condition: ☐ Sound ☐ Cracked ☐ Root Intrusion ☒ **Loose Brick** ☐ Deteriorated

Infiltration: ☐ None ☐ Joint ☐ Cracks ☒ **Mortar** ☐ Roots ☐ Wall

loose bricks

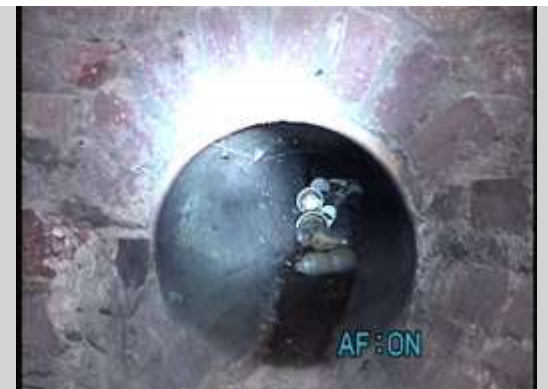
7 O'Clock Inflow

Deposits: ☐ None ☐ Mud ☐ Sludge ☒ **Debris** ☐ Grease

Silt Depth: **0** (in.) Deposits Extent: **Medium**
